# Manhole Inspection Summary

Manhole # S21M\_\_047MH

Insp Date: **3/21/08 8:27 AM**

**Location** Address: **1900 ramsay st**

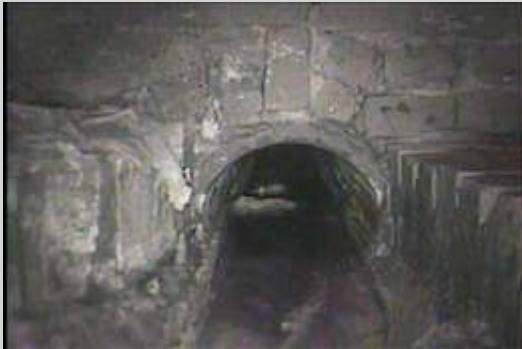
12 O'Clock Outflow

8 in. Circular Gravity Sewer  
Pipe Out @ 12 O'Clock

Pipe Height: **8.4** (in.) Rod and Bar (Angled)  
Pipe Material: **Clay** ☐ Pipe Lined  
Invert Depth: **9.70** (ft.) Flow Characteristics: **Slow**  
Deposits: ☒ None ☐ Mud ☐ Sludge ☐ Debris ☐ Grease  
Silt Depth: **0** (in.) Deposits Extent:  
Infiltration: **None** Pipe Seal Cond: **Sound**
